# The role of fungi in biodeterioration of sandstone with reference to Mahadev temple, Bastar, Chhatisgarh

Sanjay Prasad Gupta<sup>\*1</sup> and Kavita Sharma<sup>2</sup>

<sup>1</sup>Archaeological Survey of India, Raipur Circle, Raipur (Chhatisgarh), India.

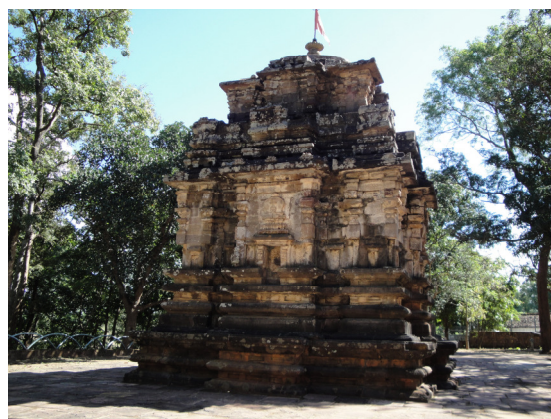
Fig 2. Mahadev temple, Bastar (Before conservation )

The patches on this monument pertain to fungi that are part of the total vegetational growth over their surface.

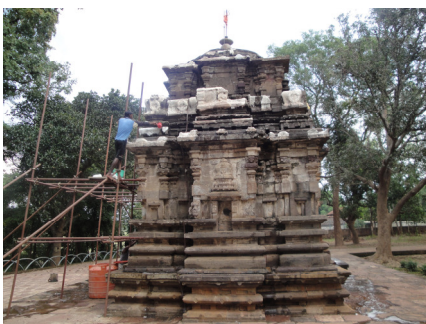
Fig 4. Mahadev temple, Bastar (During conservation)

The steps taken by Archaeological Survey of India for the removal of dust and dirt accretion upkeep of stones in neutral pH by soft brushing. The fungus was removed by applying 2-3% solution of ammonia in water and scrubbing with nylon brush. Black patches appeared after removal of thick layer microorganism which was washed out with the help of dilute solution of oxalic acid in water. A dilute solution of a non ionic detergent with liquid ammonia was applied on treated surface to remove dirt, dust and little amount of acid and ammonia if remained on the surface during the chemical treatment. Lime wash, red ocher and iron oxide accretion were removed using dilute (10-15%) aqueous acetic acid and oxalic acid solution as per the suitability and afterwards neutralized using aqueous ammonium hydroxide solution.

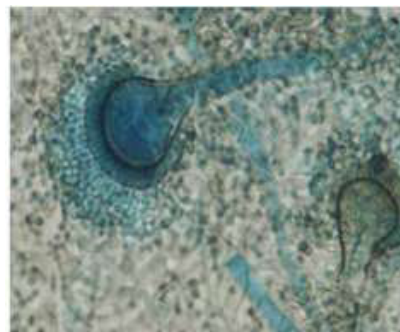
*Aspergillus fumigatus*

Fig 5. Fungal species on Mahadev temple

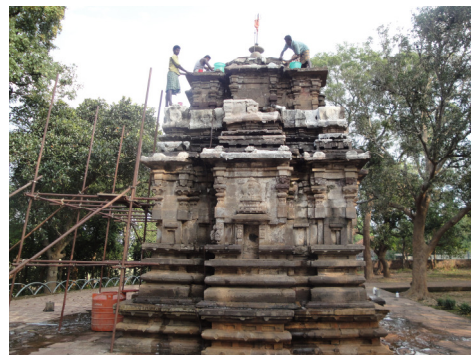
Fig 6. Mahadev temple, Bastar (During conservation)

Biocides refer collectively to bactericides, fungicides, algicides, and herbicides. They are frequently used to eliminate and inhibit biological growth. Several studies exist on the effect of biocides on the activity and growth of microorganisms on stone in tropical regions (6). Biocides may inhibit the metabolic activity of target organisms, thereby causing irreparable damage and even death. Numerous studies have tested the effects of biocides on microbial growth on stone. Several authors have developed laboratory testing methods that evaluate the effectiveness of biocides on different organisms and stone surfaces. 2% aq. Solution of sodium pentachlorophenate was applied on clean dried surface for arrest further micro vegetation growth on said monument (7).

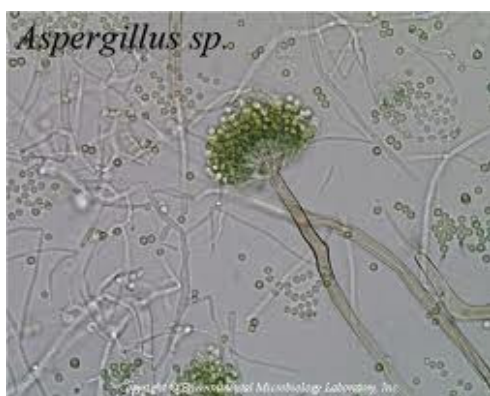
Fig 7. Fungal species on Mahadev temple

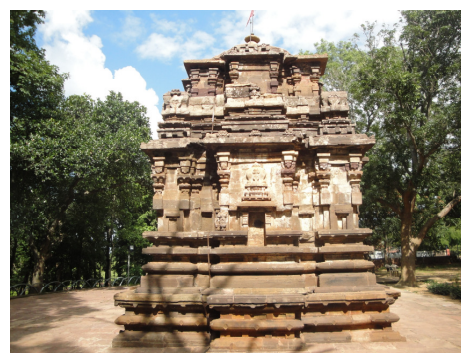
Fig 8. Mahadev temple, Bastar(after conservation)
